Influence of Iron Bacteria on the Corrosion Behavior of Carbon Steel: SEM Study

E. Hamzah^{a*}, C. L. Khohr^a, A. Abdolahi^a, Z. Ibrahim^b

^aFaculty of Mechanical Engineering, Universiti Teknologi Malaysia

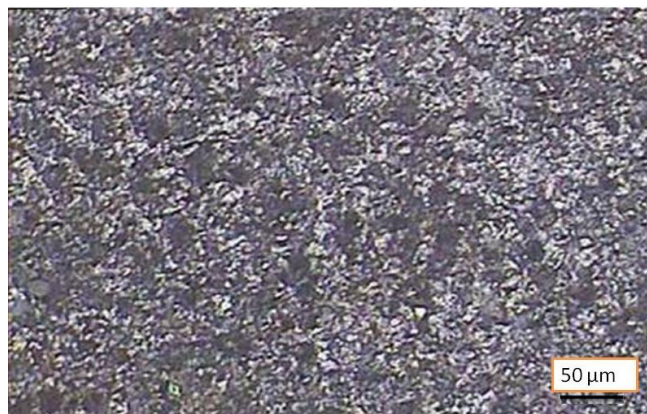
The optical micrograph and SEM image of steel exposed to bacteria inoculated medium for one month is shown in Figure 5 and 6 respectively.

Figure 5 Optical micrograph ($\times 570$) of uniform pitting on the carbon steel coupon exposed to iron bacteria inoculated medium for one month

The occurrence of uniform pitting corrosion on the steel surface is observed. In general, the appearance of steel due to MIC is accepted to be localized as it is under the influence of patchy biofilm that differential aeration cells and thus anodes and cathodes are formed. However, at some points on the steel surface, the pitted areas could be joint, thereby the appearance might look like a uniform pitting corrosion [10].
